Inspection Report

Property Address:
1234 Happy Crescent
Vancouver, BC V1N 1O1

Harrison Home Inspections Ltd

Date: 23/11/2010	Time: 1:30 PM	Report ID: Sample
Property: 1234 Happy Crescent Vancouver, BC V1N 1O1	Customer: Mr. Smart Buyer	Real Estate Professional:

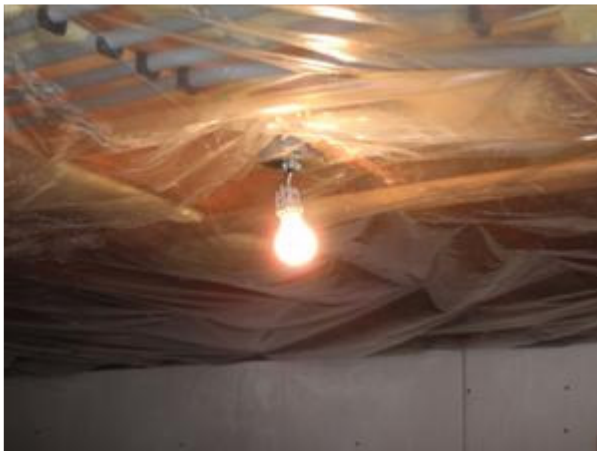
C. Picture 1

The heated crawlspace is dry and shows no past or present water ingress. The walls of the large crawlspace have loosely fastened insulation on the foundation walls. The bare light bulbs have no safety covers (Picture 1). Minor.

Recommendations: *fastening/adhering the insulation to the foundation walls for better thermal efficiency. Add safety cages to bare light bulbs for safety.*

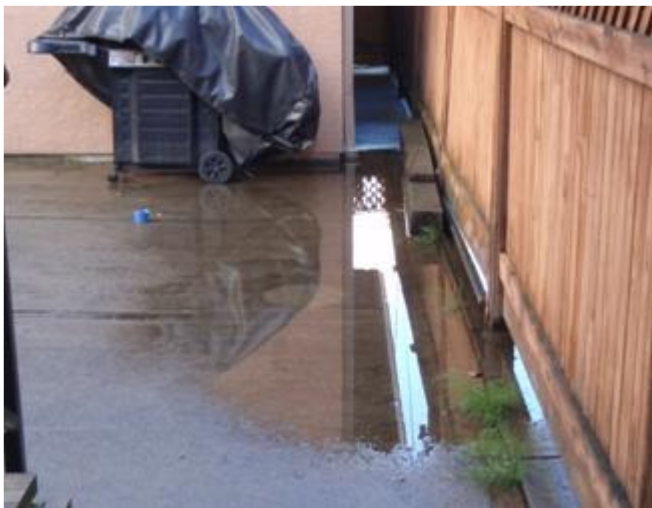
D. Picture 2

surface area drainage (Picture 2). The drainage between properties has an unfamiliar trough for drainage and standing water was observed (Picture 3). The slope of the east sidewalk is towards the house (Picture 4). There are no signs of issues with the below ground drainage system at this time, and there are no indications of water ingress into the lower basement level or crawlspaces where observable. There is a sump at the front of the property (Picture 5).

Recommendation: *Have a qualified drainage company come and inspect drainage areas at back patio and between properties.*

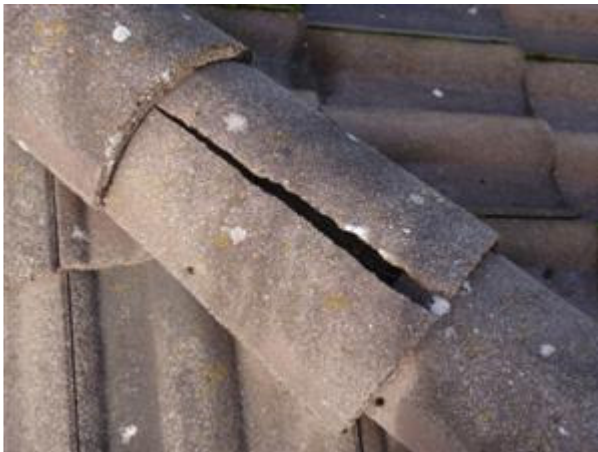
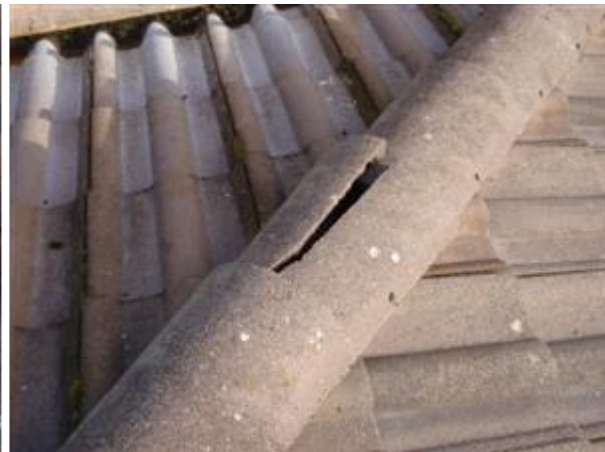
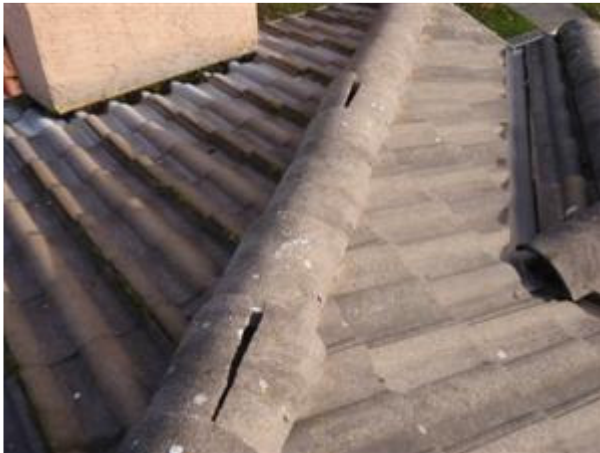
The concrete tile roof covering is in good condition with no missing or dislodged tiles. There are two ridge cap tiles which are broken and exposing the wood beneath (Picture 1,2,3). There is a negative slope on the top peak ridge cap which may be vulnerable to water flowing beneath (Picture 4). The ridge peaks on the garage have gaps and exposed nails at the junctions (Picture 5,6,7). Some edge moss observed. Periodic inspection is necessary to maintain proper function.

Recommendation: *Further inspection and repairs by a qualified roofing company.*

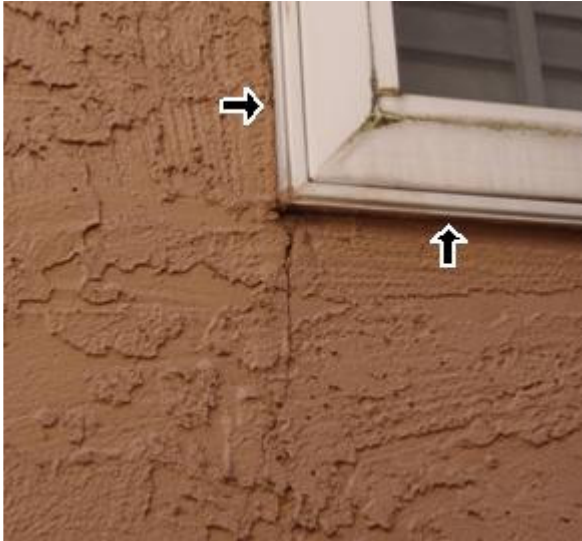
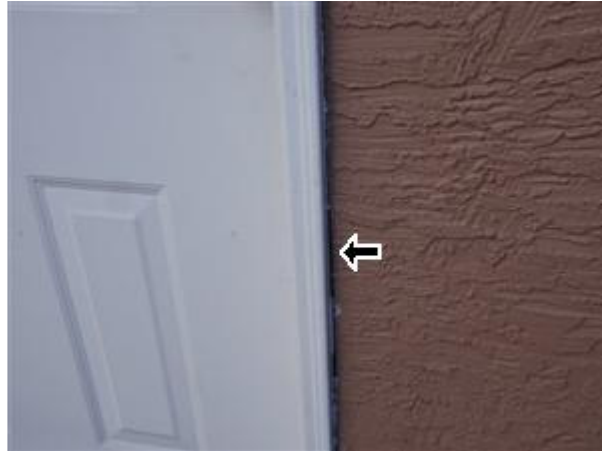
The stucco walls have a few hairline cracks located mainly around the window areas. These typically occur from moisture penetration around the window frames. The windows of the lower and upper levels and wall penetrations are not sealed where the stucco meets the junction (Picture 1,2). The stucco at the retaining wall to the back basement door has a

Recommendation: *Sealing these junctions to prevent moisture penetration.*

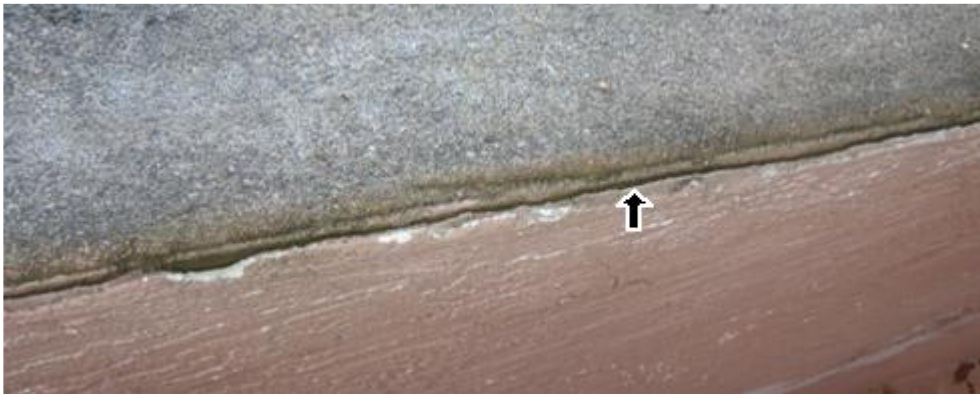
G. Picture 3

The stucco walls have a few hairline cracks located mainly around the window areas. These typically occur from moisture penetration around the window frames. The windows of the lower and upper levels and wall penetrations are not sealed where the stucco meets the junction (Picture 1,2). The stucco at the retaining wall to the back basement door has a gap at the top (Picture 3).

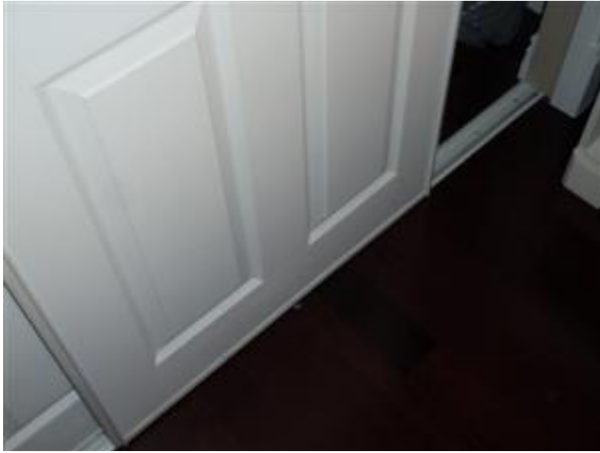
I. Picture 1

One of the bedroom closet doors is not sliding closed (Picture 1). The door serving the upper southeast bedroom does not latch (Picture 2). **Minor repairs.** The other interior doors and hardware are functioning.

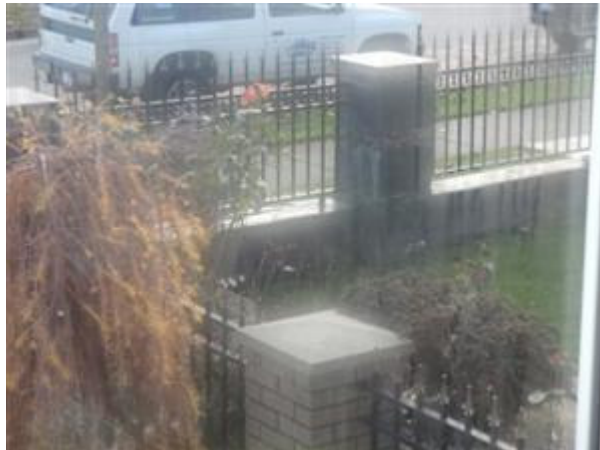
J. Picture 1

The sampled windows are functioning and show no cracks or broken latches. The main level southwest den has a failed seal in the middle picture window (Picture 1). Replace as necessary.

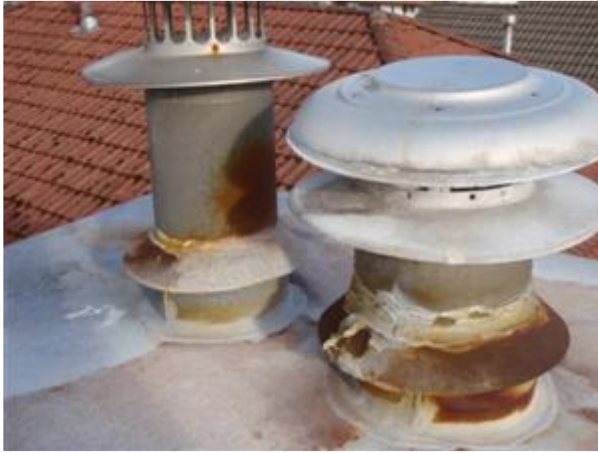
K. Picture 1

The flue pipes on the roof show some light surface corrosion and are sealed at the skirt (Picture 1).

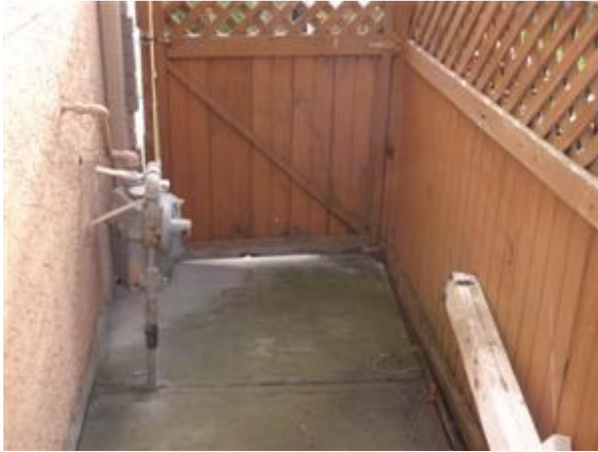
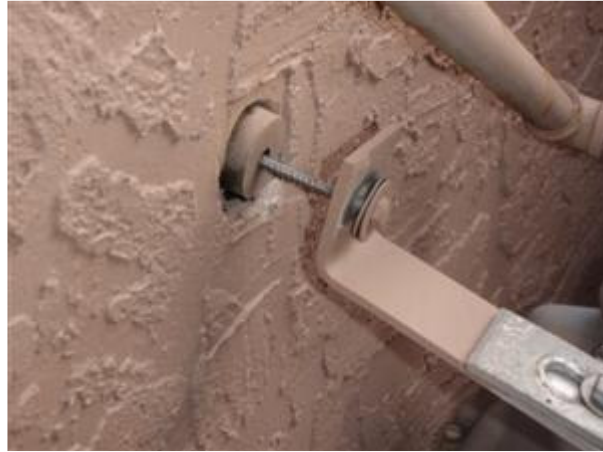
No concerns with the front porch. The front right walkway has settled creating a small trip hazard and misalignment of the gate. The left walkway has settled at the gate and has pulled the gas meter out from the wall (Picture 1,2).

Recommendation: *Repairs to walkway at gas meter to prevent further issues.*

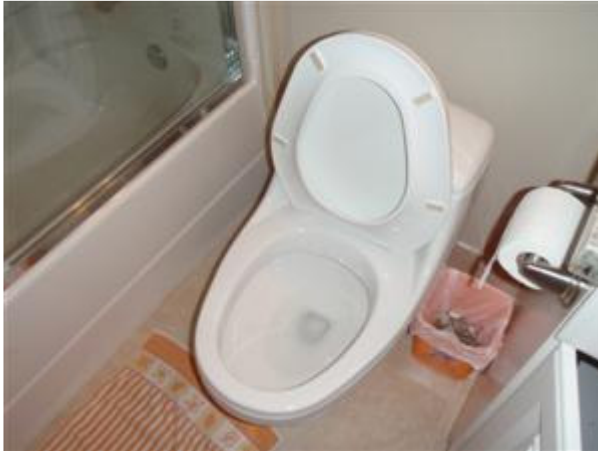
E. Picture 1

The basement toilet is loose on its mount (Picture 1). No cracks or leaks to the tanks or toilets. The toilets are functioning and the others fastened securely.

Recommendation: *Replace wax seal of basement toilet and fasten securely.*

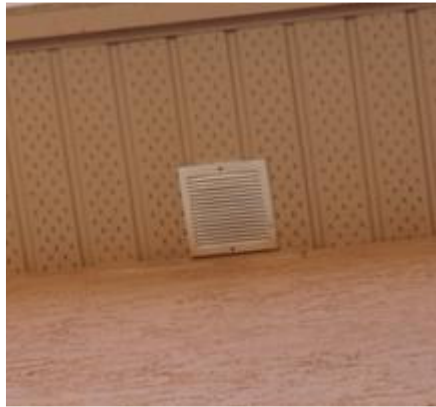
F. Picture 2

The bathroom fans are functioning with a medium loudness and vented to the exterior. Note: the upstairs bathroom fans are vented to the soffits which is not the better practice however there were no indications of moisture issues in the attic (Picture 1). The better practice would be to vent through the roof but an alternative in this situation would be to close off the soffit in that area and add a directional hood in place of flat grille (Picture 2).

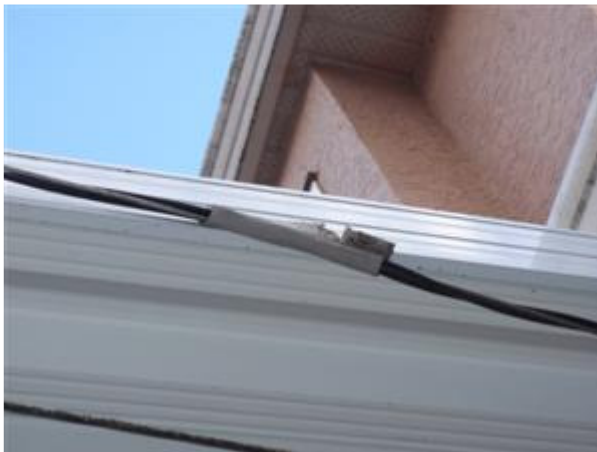
A. Picture 1

The service conductors are contacting the metal awning (Picture 1). It appears it could be a potential safety concern. The meter is missing its security tab (Picture 2). **Recommendation: Have a licensed electrician or BC Hydro inspect for safety.**

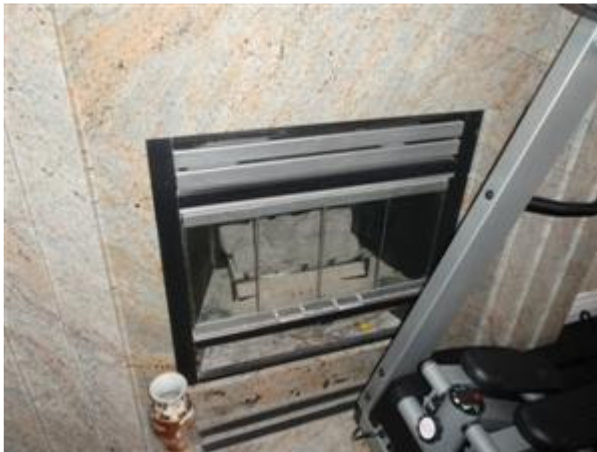
C. Picture 1

Both gas fireplaces shows no visible concerns however the pilots were not lit and therefore were not tested (Picture 1).

Recommendation: *Have written in the contract that both fireplaces will be tested and functioning upon possession or something to that nature.*

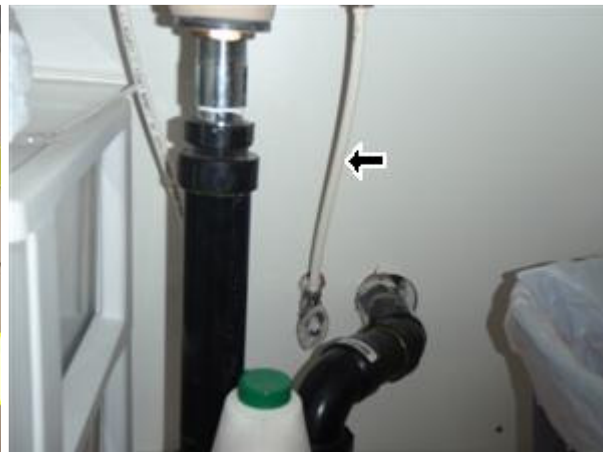
A. Picture 2

All fixtures were functioning with no leaks. Some hot and cold lines to fixtures are plastic (Picture 2). **Recommendation:** *Upgrading any plastic lines to fixtures with burst proof braided stainless steel.*

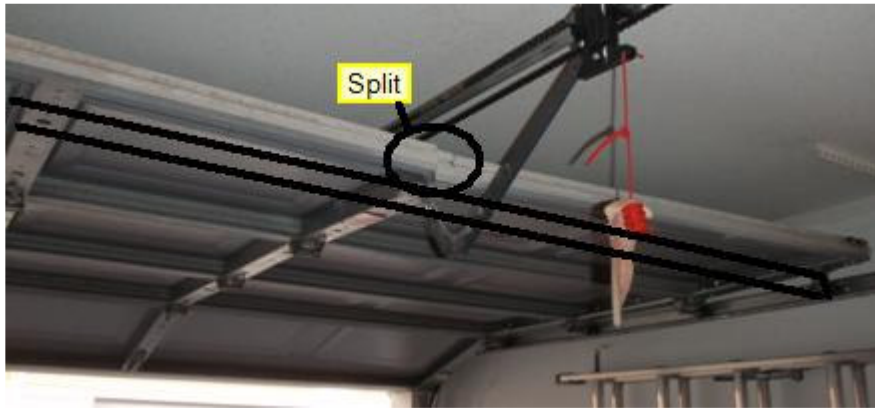
G. Picture 1

The single garage door is missing a reinforcing bar at the top of the door (Picture 1). The door is not functioning as designed. The motor was functioning when tested.

Recommendation: *Repairs.*

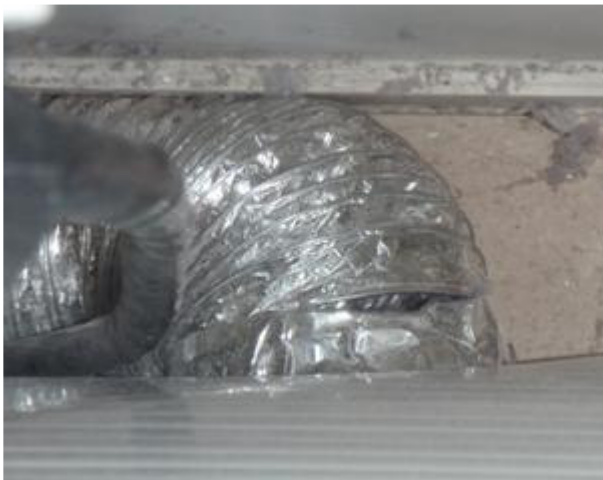
H. Picture 1

There is a hole in the flexible aluminum duct behind the dryer (Picture 1). No other concerns.

Recommendation: *Minor repairs.*

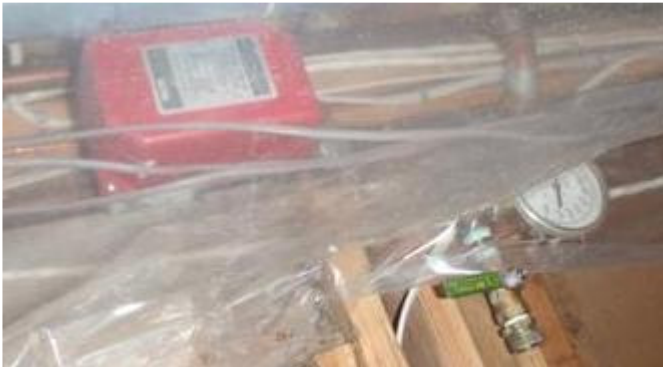
E. Picture 1

There is a fire prevention sprinkler system located throughout the house except a head was not observed in the large crawlspace (Picture 1).

Recommendation: *Have a sprinkler head installed for safely storing belongings and fire safety in the crawlspace.*
