Inspection Report

Property Address:
1234 Happy Crescent
Vancouver, BC V1N 1O1

Harrison Home Inspections Ltd

Date: 23/11/2010	Time: 1:30 PM	Report ID: Sample
Property: 1234 Happy Crescent Vancouver, BC V1N 1O1	Customer: Mr. Smart Buyer	Real Estate Professional:

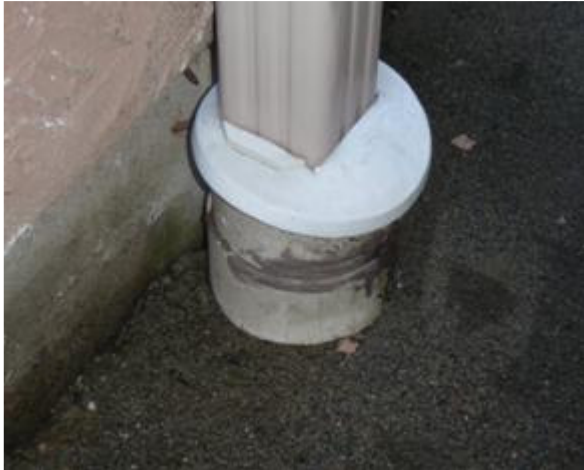
D. Picture 1

The drainage is today's standard of PVC (Picture 1). There is significant ponding at the back patio area indicating poor surface area drainage (Picture 2). The drainage between properties has an unfamiliar trough for drainage and standing water was observed (Picture 3). The slope of the east sidewalk is towards the house (Picture 4). There are no signs of issues with the below ground drainage system at this time, and there are no indications of water ingress into the lower basement level or crawlspaces where observable. There is a sump at the front of the property (Picture 5).

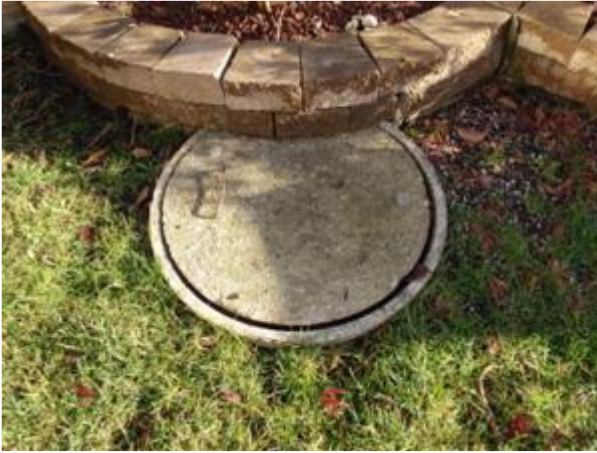
D. Picture 5

surface area drainage (Picture 2). The drainage between properties has an unfamiliar trough for drainage and standing water was observed (Picture 3). The slope of the east sidewalk is towards the house (Picture 4). There are no signs of issues with the below ground drainage system at this time, and there are no indications of water ingress into the lower basement level or crawlspaces where observable. There is a sump at the front of the property (Picture 5).

Recommendation: *Have a qualified drainage company come and inspect drainage areas at back patio and between properties.*

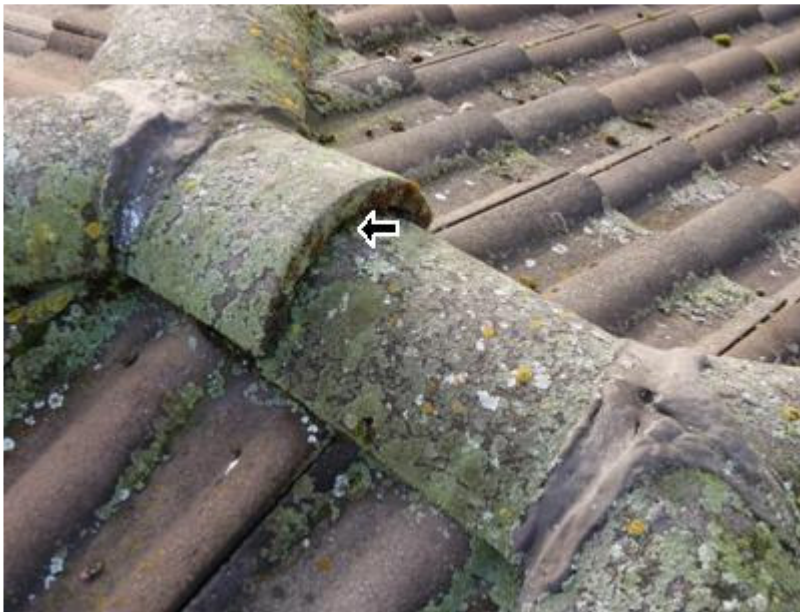
E. Picture 4

The concrete tile roof covering is in good condition with no missing or dislodged tiles. There are two ridge cap tiles which are broken and exposing the wood beneath (Picture 1,2,3). There is a negative slope on the top peak ridge cap which may be vulnerable to water flowing beneath (Picture 4). The ridge peaks on the garage have gaps and exposed nails at the junctions (Picture 5,6,7). Some edge moss observed. Periodic inspection is necessary to maintain proper function.

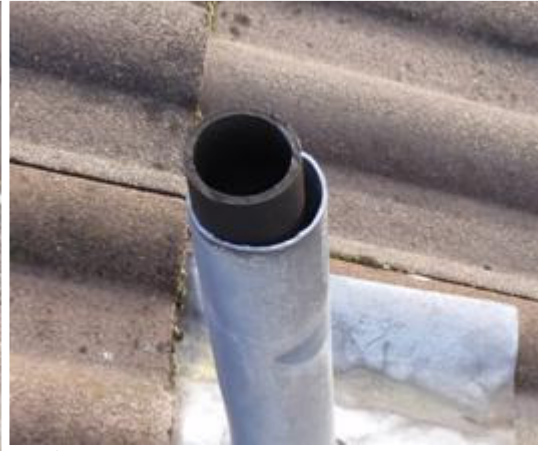
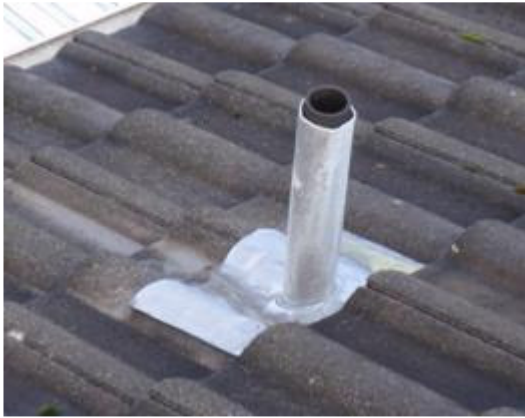
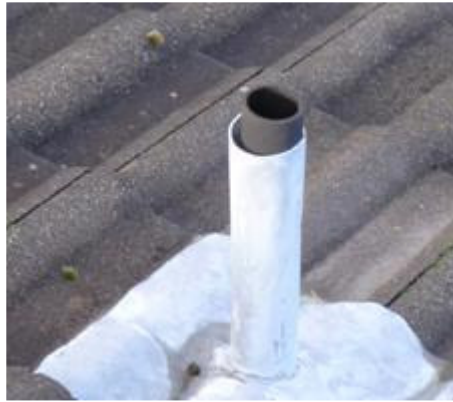
The 3 plumbing vents on the roof are without caps (Picture 8,9,10). The roof penetrations are detailed for water shedding.

Recommendation: *Have roofer install appropriate caps.*

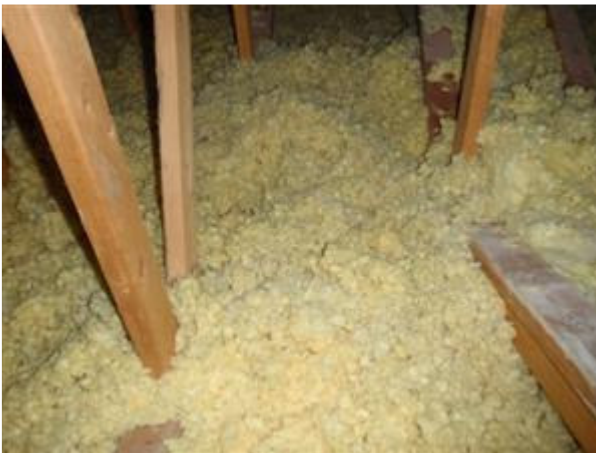
F. Picture 1

The loose fill insulation measured a depth of approximately 14 inches which is today's standards (Picture 1).

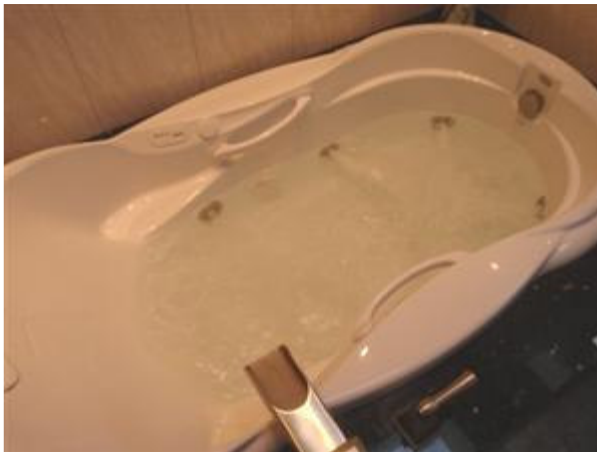
C. Picture 1

The jacuzzi tub is functioning with no leaks and is protected by a functioning GFCI (ground fault circuit interrupter) at the panel (Picture 1).

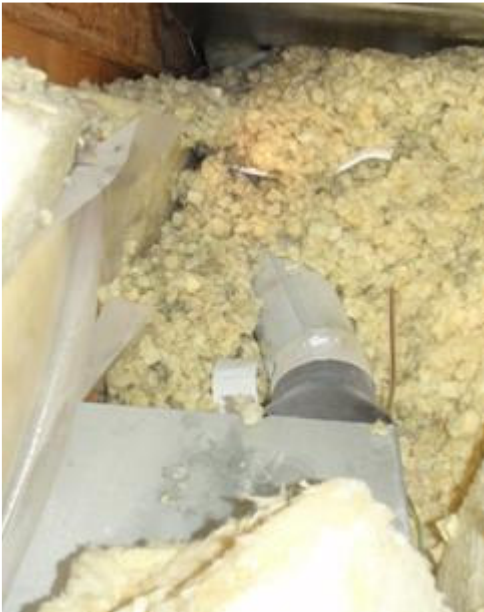
F. Picture 1

The bathroom fans are functioning with a medium loudness and vented to the exterior. Note: the upstairs bathroom fans are vented to the soffits which is not the better practice however there were no indications of moisture issues in the attic (Picture 1). The better practice would be to vent through the roof but an alternative in this situation would be to close off the soffit in that area and add a directional hood in place of flat grille (Picture 2).

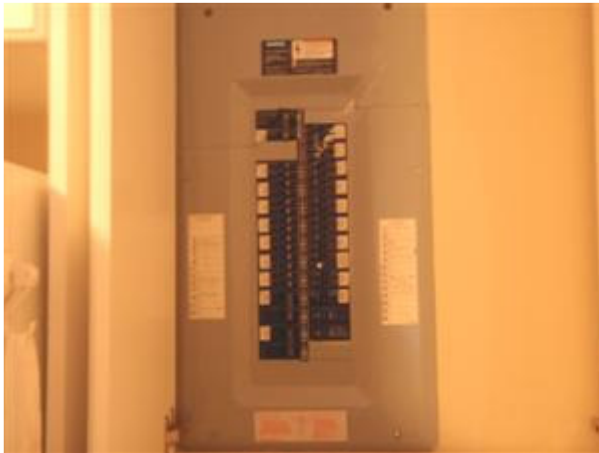
A. Picture 3

The main panel is located in the northwest corner of the basement. It is accessible (Picture 3), shows no burnt, damaged, or corroded wires (Picture 4), and is labeled. Appropriate circuit breakers and sized wires were used for specific circuits (i.e. 40 amp for the range, 30 amp for the dryer, 15 amp for general circuitry). There are two breaker positions available.

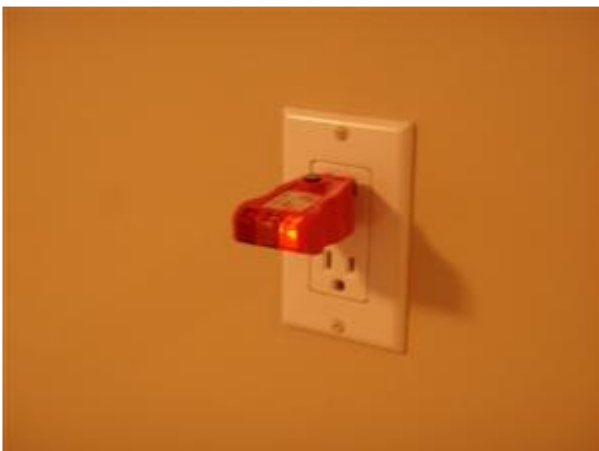
B. Picture 1

- The outlet on the east wall of the basement kitchen has an open neutral (Picture 1).
- There is an abandoned wire under the back deck (Picture 2)
- No GFCI protected outlets in the main level and ensuite bathrooms
- The main kitchen counter has a split receptacle outlet where the lower has no power and the upper has an open ground (Picture 3,4)
- Another counter outlet in the main kitchen has an open ground (Picture 5).
- West outlet in the front den has no power and is not on a switch (Picture 6).

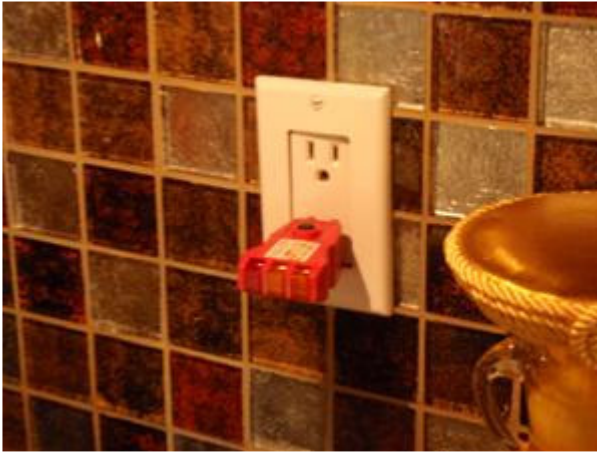
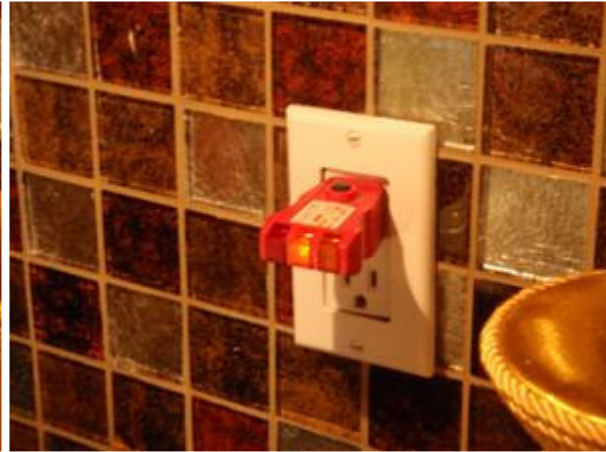
- ground (Picture 3,4)
- Another counter outlet in the main kitchen has an open ground (Picture 5).
- West outlet in the front den has no power and is not on a switch (Picture 6).

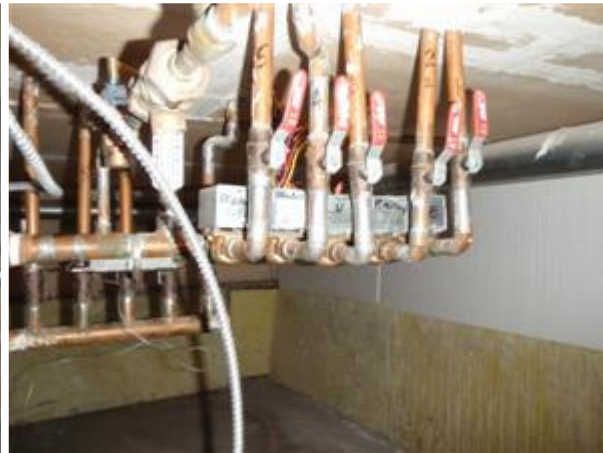
A. Picture 2

The Teledyne Laars Mini Therm II boiler has a Copper finned heat exchanger and cast iron components. All zone valves and thermostats are functioning and it is fairly clean showing no leaks or indications of immediate concerns at this time (Picture 2). This type of boiler along with stainless steel are the two most recommended boilers to have with Polybutylene piping as the distribution of the water, which is the case in the house (Picture 3). Overall the installation shows no significant concerns however adding a "Spirovent" in the system would reduce ongoing problems with corroding of steel components and air in the lines causing circulation problems. Regular servicing is necessary with this type of system.

Recommendation: *Have a servicing by a licensed heating company upon possession and inquire about having a Spirovent installed.*

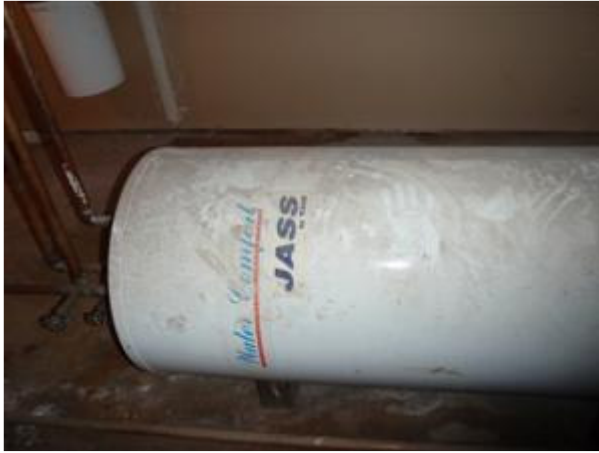
C. Picture 1

The hot water storage tank date is unknown. It is installed correctly, has no leaks, and is functioning (Picture 1). It is functioning in conjunction with the boiler using heat exchange (Picture 2).

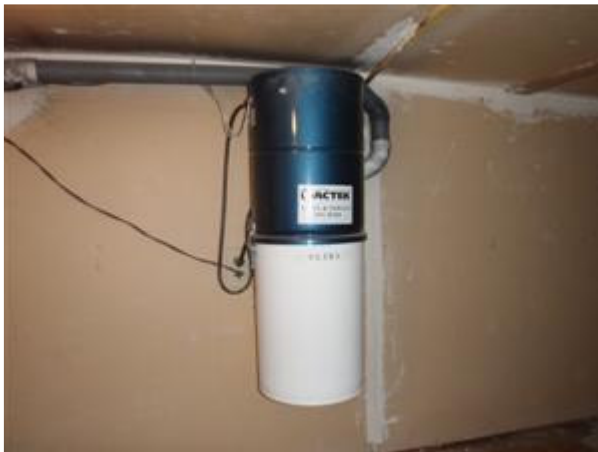
F. Picture 1

Tested ok (Picture 1).

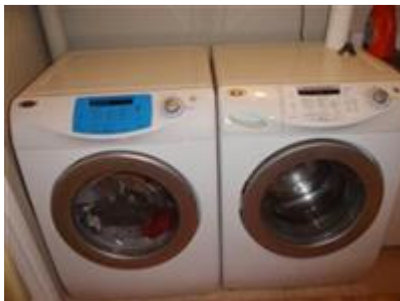
I. Picture 1

The washer and dryer were both functioning at the time of inspection (Picture 1). The pressure hoses show no cracks or bulges.

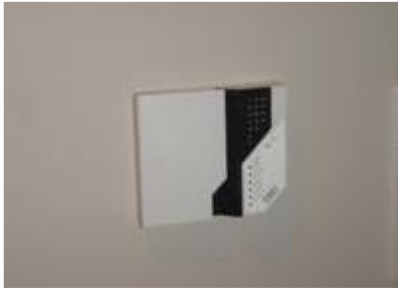
D. Picture 1

Noted but not inspected or tested (Picture 1).
